# Climate and Decay: The impact of the urban climate on built landscape

**Conference paper | Published version**

COLWILL, Simon (2017): Climate and Decay: The impact of the urban climate on built landscape. In: Creation/Reaction. ECLAS Conference 2017, University of Greenwich, London UK. Conference proceedings, pp. 314–332. ISBN: 978-0-9935909-6-2

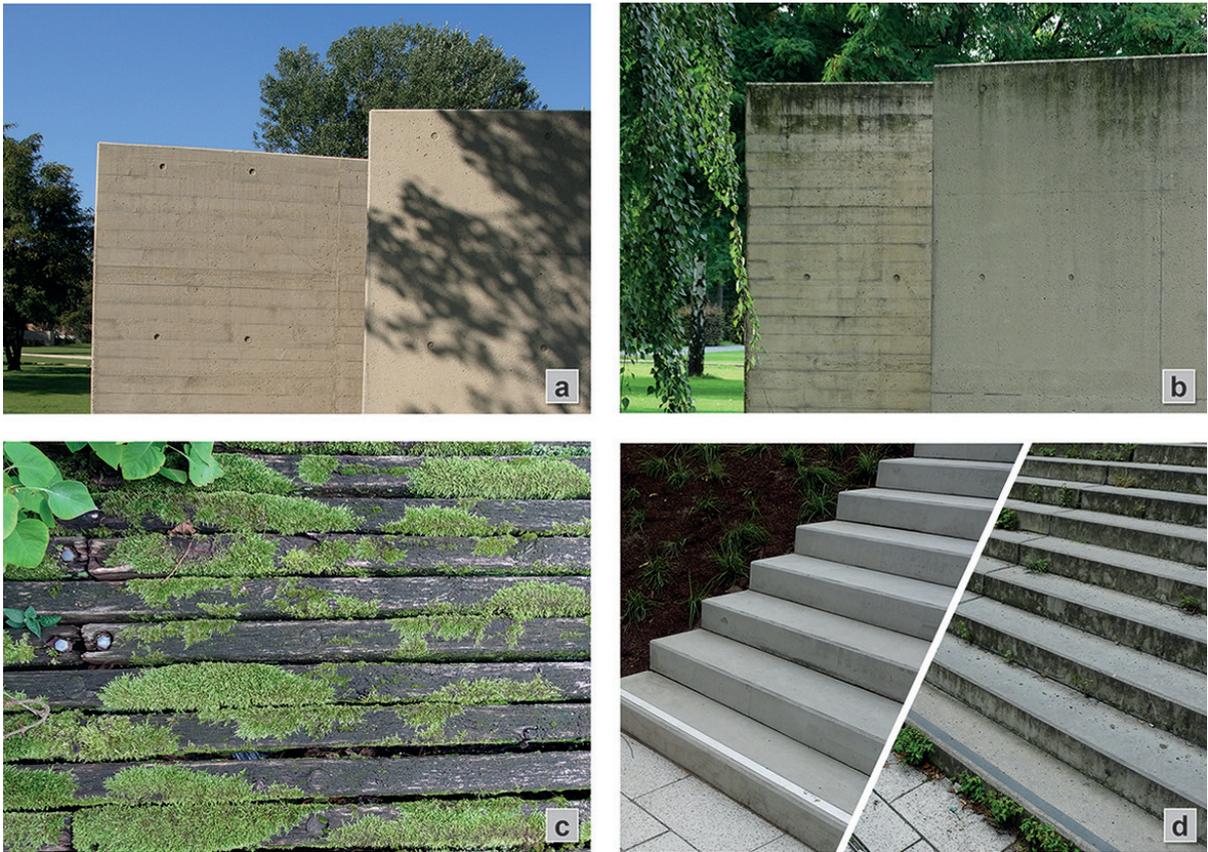
Fig. 3: a/b) Deposits of airborne sediments on concrete wall (exposed location): year 1 / year 10. c) Biological growth on wooden deck (sheltered location): year 17. d) Biological growth only on riser due to reduced trampling and maintenance (semi-exposed location): year 1 / year 7. [Photos: S. Colwill]

**Wind** causes direct stress to the structure and also transports airborne pollutants (e.g. industrial, marine pollutants, vehicular traffic) and sediments [2: pp 6-7]. The deposition of airborne dust, dirt, pollen, and other atmospheric contaminants on the surfaces of built elements leads to **surface soiling** [Fig. 3a, 3b]. Factors that contribute to soiling and staining include the material properties (e.g. chemical composition, water absorptivity and porosity), degree of exposure, surface roughness (structure) and wetness [8: p 623]. This deposition is increased on the lower-velocity lee of vertical elements such as walls, edgings and at the base of street furniture as well as on structured surfaces and in the corners, joints, gaps of built works. Surfaces that are vulnerable to frequent wetting or where surface moisture is continually present are particularly prone to soiling. This process not only highlights the surface structure but also surface imperfections through time.

more vertical surfaces are predominantly dryer, and therefore fewer plants can establish [13: p 5, 8, 18: p 39]. The upper area of the wall face is influenced by the runoff of sediments from the top of the wall which often cause vertical biological staining (e.g. cyanobacteria, algae, mould) [8: p 625]. This process leads to a highlighting of the surface structure of the wall. Walls from individual units (e.g. bricks, stone, concrete) and vertically structured surfaces lead to a more even spread of surface soiling. Surface irregularities, for example due to production process faults such as the soiling of concrete formwork, can also become more visible through soiling. The bottom 20-30cm of the wall is strongly influenced by rising damp and the splashback of rainwater which often leads to soiling, biological growth, staining and material deterioration [8: p 629]. Surface soiling on smooth and light coloured surfaces (e.g. smooth exposed concrete) becomes especially visible.
