Real demonstration results of BEM performance simulation using BIM-SPEED Toolset

Deliverable 4.2 – Energy Performance Report – Lichtenrade demo

Harmonised Building Information Speedway for Energy-Efficient Renovation

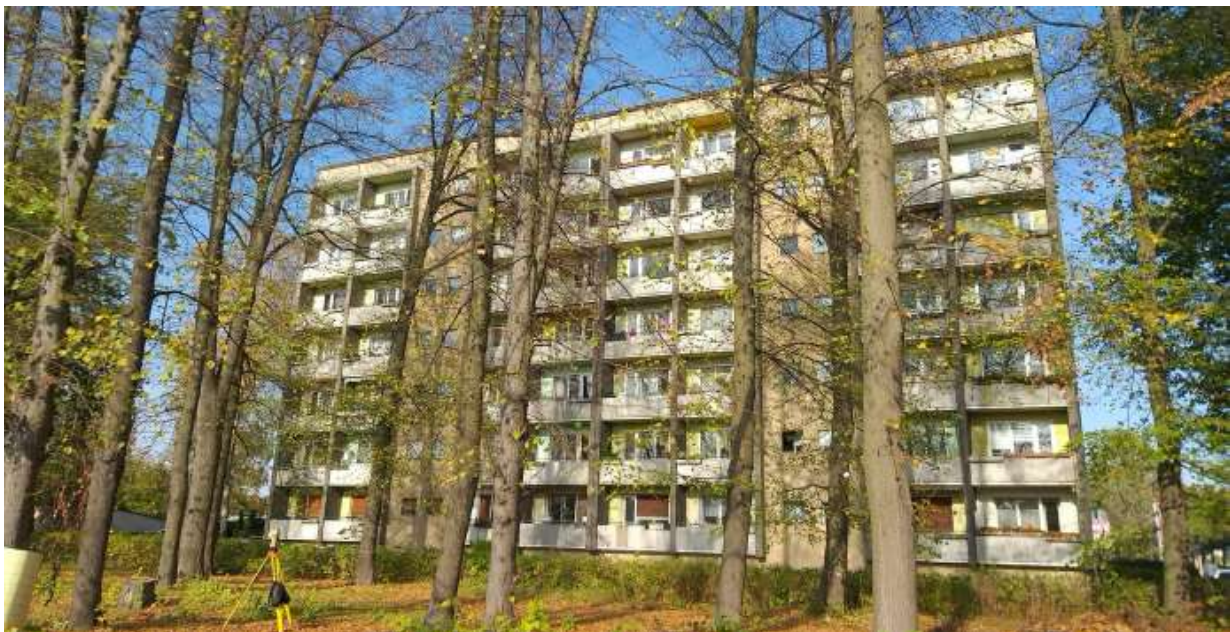
Figure 2: External view of the building

The building consists of two separate structures (building 42 and 43), a basement, one ground floor and 6 upper floors with a total of 55 dwellings. The constructive characteristics of the building are consistent with the construction period and are characterized by not-insulated walls, reinforced concrete and brick mixed floors. Following photos shows the external view of the building.
